Manhole Inspection Summary

Manhole # S04CC2004MH

Insp Date: **9/26/06 7:16 AM**

Location Address: **3501 LABYRINTH RD**

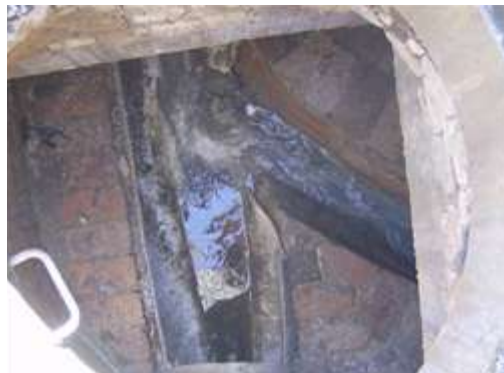
Top View

Frame leaks. Adjustment deterioration, loose brick and infiltration. Bench and Channel debris.

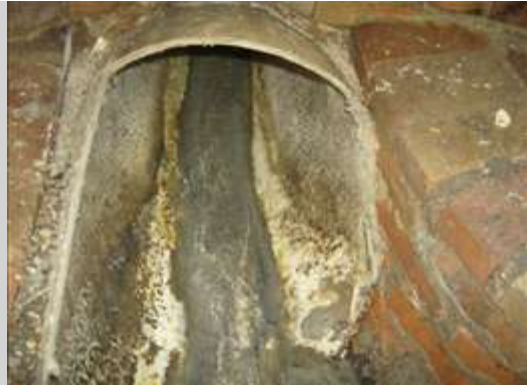
18 in. Circular Gravity Sewer Pipe Out @ 12 O'Clock

Deposits: ☐ None ☐ **Mud** ☐ Sludge ☐ Debris ☒ **Grease**

Infiltration: **Evidence** Pipe Seal Cond: **Cracked**

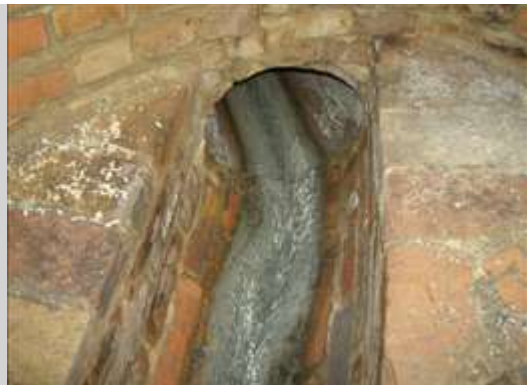
12 in. Circular Gravity Sewer Pipe In @ 4 O'Clock

Deposits: ☐ None ☐ **Mud** ☐ Sludge ☐ Debris ☒ **Grease**

Infiltration: **Evidence** Pipe Seal Cond: **Cracked**

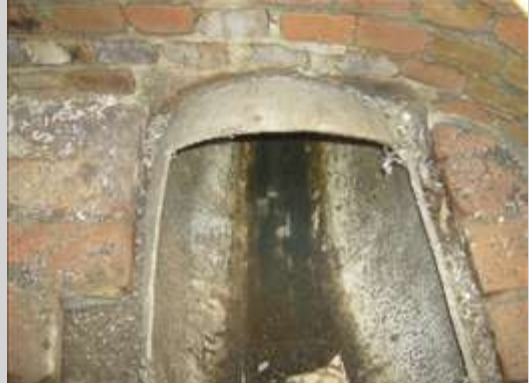
18 in. Circular Gravity Sewer

Deposits: ☐ None ☒ **Mud** ☐ Sludge ☐ Debris ☐ Grease

Infiltration: **Evidence**
